# GEOTECHNICAL EVALUATION REPORT

CARTER ROAD SLIDE  
CLEVELAND, OHIO

SME Project Number: 076822.27  
March 29, 2019

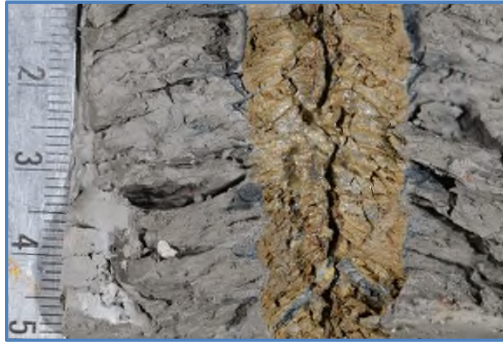
**Carter Road Sample**

Below the sands and silts, we encountered a medium stiff to stiff layer of varved (see description and photographs below) silty/lean clay, which we've identified as the weak (low shear strength) layer within this subsurface profile. This layer extends from a depth of about 42 to 61 feet (elevation 567 to 548 feet). Direct shear test results indicate that soils within this layer have a post-peak friction angle of about 17°, which is low. Our slope stability analyses indicate that this layer is the likely failure plane and our inclinometer readings, also presented in the Appendix A, confirmed movement within this layer. The condition at Carter Road is very similar, if not the same as, the failing slope conditions at the Irishtown Bend where this weak lacustrine clay layer also exists.

Varved clays are lacustrine deposits (soil deposited through water onto lake bottoms) of thinly bedded layers of silt and clay. Most of the lacustrine deposits in our area are post glacial deposits that were formed after the glaciers left our area. They are typically found over the top of glacial till deposits as is the case at Carter Road. The layering occurs between seasons when lakes goes from unfrozen to frozen and the water becomes calmer beneath this ice. The silt particles are larger and heavier and settle to the lake bottom when the water is open or unfrozen. Once the lake freezes, and the water turbulence calms down, the smaller clay particles settle to the bottom. Each silt/clay layer is like the ring of a tree and represent one season. The thicknesses of the layers vary depending on sediment load and how long the lake is frozen over. The layering in this case does not necessarily equal one year of time but only one cycle of freezing. Not all lacustrine clays are varved. Portions of the weak lacustrine clay layers sampled in our borings did not show varving.
